Broward County ITS Case Study

Technical Paper U-T4E-20004

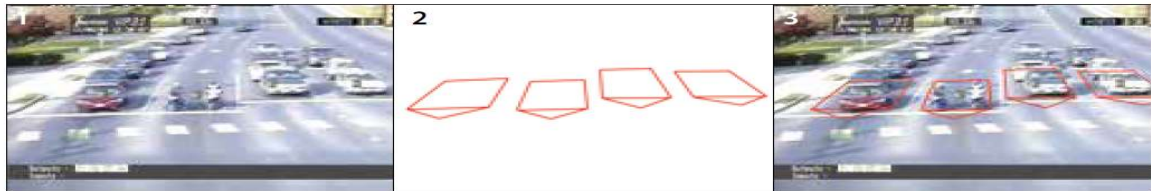
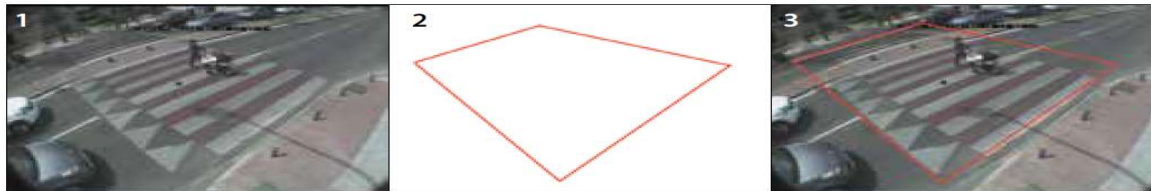
1. A video camera is monitoring traffic. Its video signal is used as input for the detection unit.
2. During set-up of a video detector, detection zones are superimposed onto the video image.
3. Vehicles, pedestrians or bicyclists crossing the detection zones are detected.

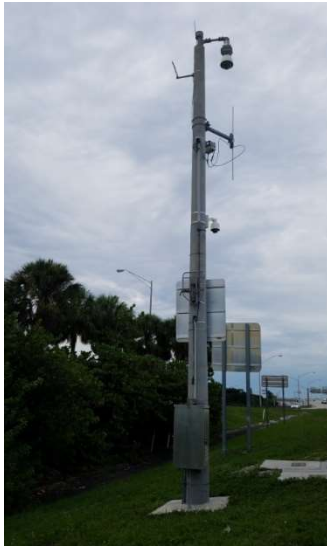
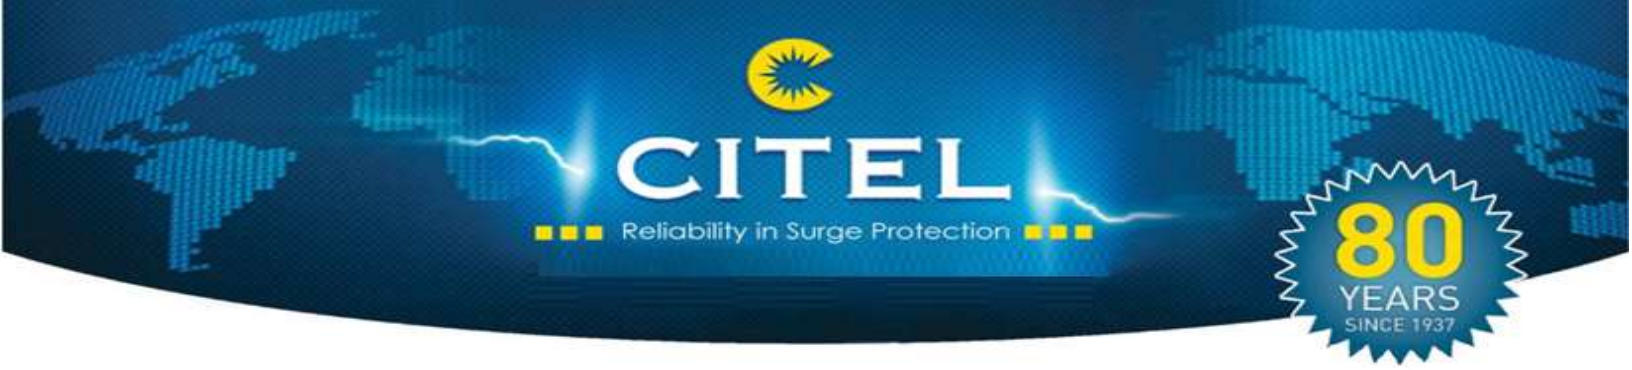
Over \$ 8 billion dollars is currently being invested across the by the US Department of Transportation in the ITS market in 2016. Any premature failure of critical components like traffic cameras and vehicle detection systems, would be considered a threat to Federal, State and County strategic transportation plans. Broward County contacted Citel because it's camera systems were failing prematurely outside of its designed life cycle. These failures increased the risk of traffic accidents; which in turn increased the risk to both lives and vehicles moving on both local and state highways. After reviewing what components failed, it was believed the failures were being caused by lightning and transients surges.

Citel was called in to investigate the failed systems. Data was gathered in the field by opening the ITS equipment cabinets and reviewing industry installation practices. Technical information was added from the camera manufacturers and from our the Citel surge testing laboratory based in Miramar Florida. Citel engineering completed the risk analysis and using the data gathered from our test lab, resulted in similar failures to be seen. This data clearly showed that surge protection was required at all critical points entering and leaving the ITS cabinet. This included signal and power to the cameras, data to the central office and all AC and DC power. After review of the cabinet layout, suggestions were made concerning grounding and bonding inside of each of the cabinets, referencing IEEE 1100-2005 (Emerald Book) and Motorola 587 Equipment Installation guides.
